Vehicle Inspection Report

Conducted by Classic Performance Engineering, Bicester

Date Completed 08/02/2022

Make	Ferrari	Engine no.	
Model	308GTB	Registration	308 AFK
Chassis no.		Recorded Mileage	88,665

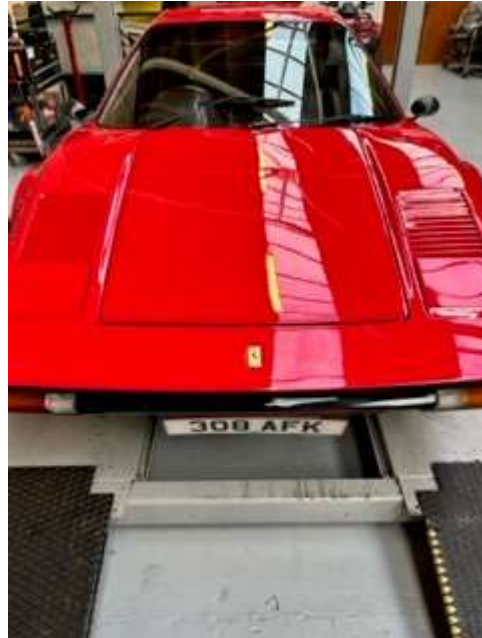
01

Area of Inspection	Comments																																				
Bodywork	Paint on body is in good condition (Image 1-5) Rust hole in lower front bumper (Image 6) Chip paint repairs on the wings / doors Front bonnet fouls wiper blades / misaligned (Image 7-8) Mouse hole in rear bumper panel near exhaust tail pipe, repair needed to stop fabrics from reaching exhaust when hot. (Image 9-10)																																				
Brightwork	No chrome, lenses all OK																																				
Wheels & Tyres	See images, tyres 2000, 22+ years old. Advise replacement of all years. (Image 11-19)

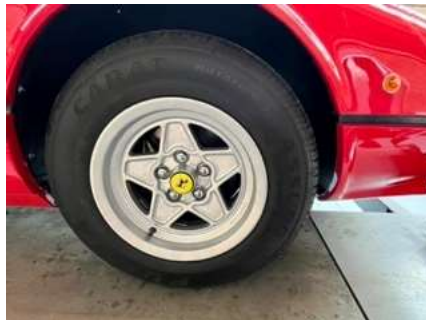
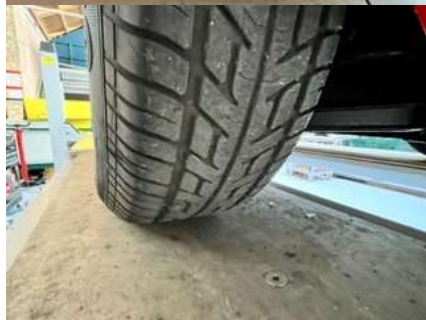
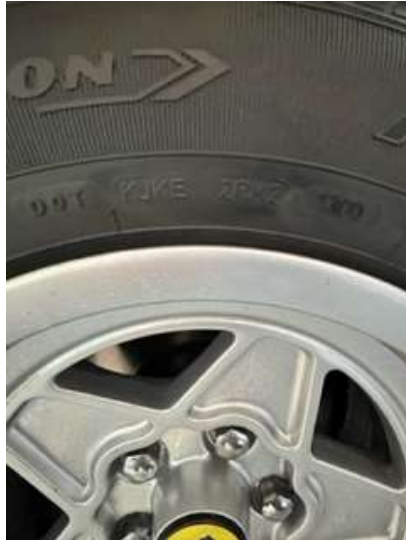
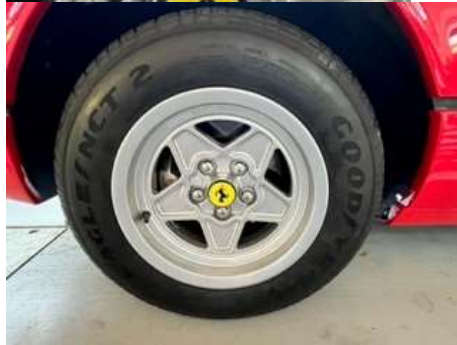
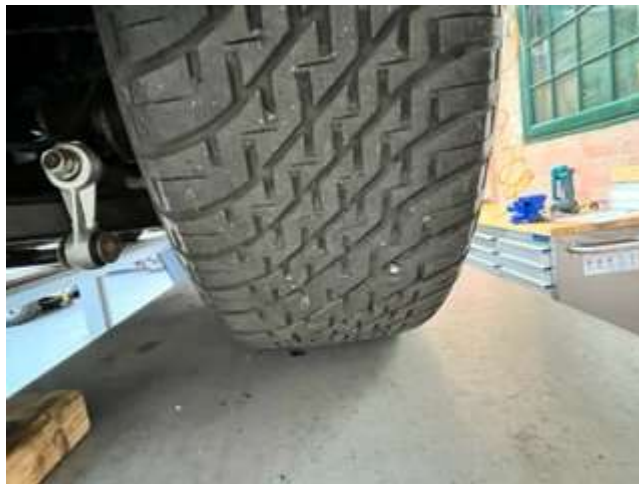
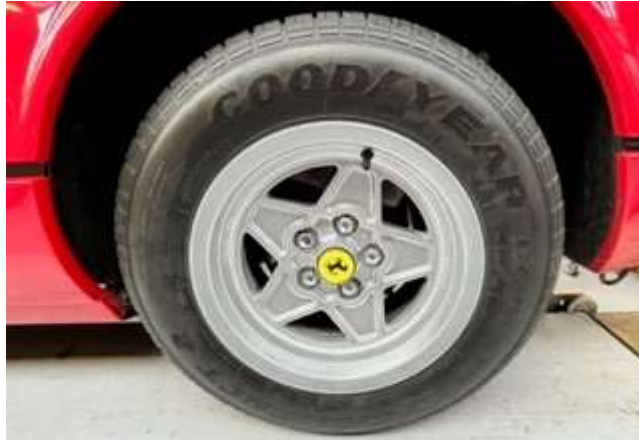
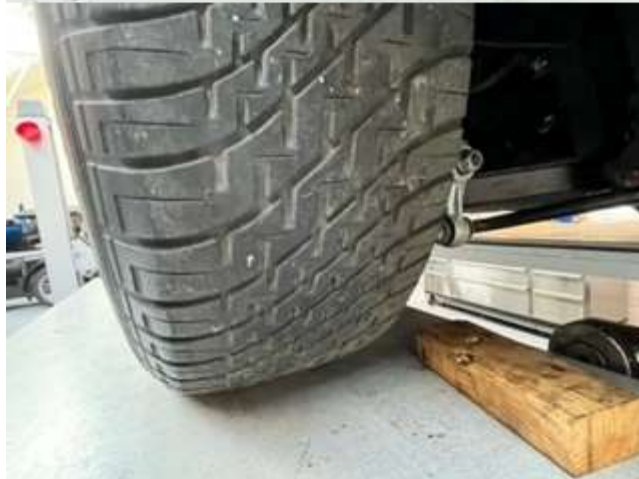
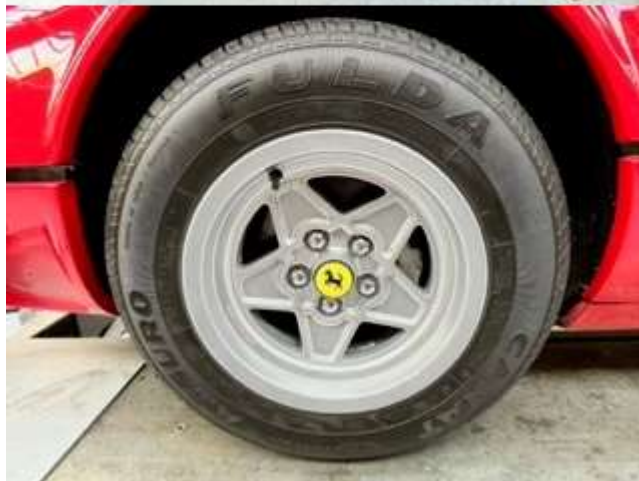
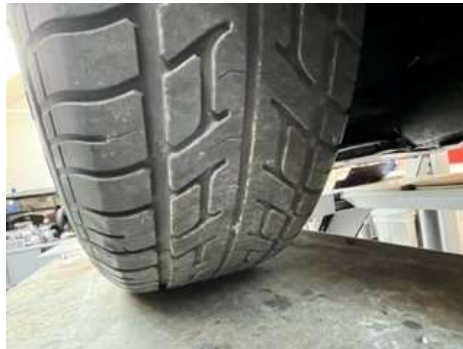
<table><tr><th>Position</th><th>Wheel Cond.</th><th>Original Spec.</th><th>Tyre Cond.</th><th>Size</th><th>Year</th></tr><tr><td>NSF</td><td>OK</td><td></td><td>Tread is Good, tyres 22 years old</td><td>205/70/R14 95V</td><td>DOT 1300</td></tr><tr><td>NSR</td><td>OK</td><td></td><td>Tread is Good, No date stamp</td><td></td><td>No date stamp</td></tr></table>

Area of Inspection	Comments
General Notes	Tyres are all 22+years old, Recommend replacement Trims on engine cover peeling off (Image 29-30) Mileage confirmation (Image 31) Tools and Engine Bay Storage (Image 32-33)

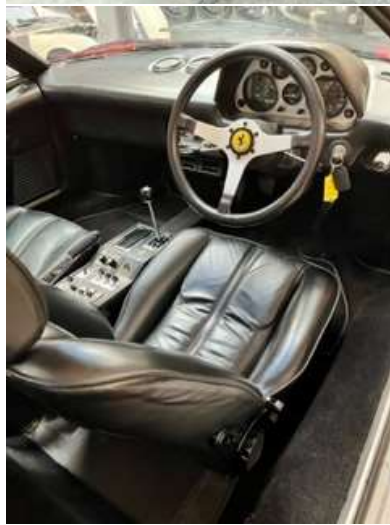
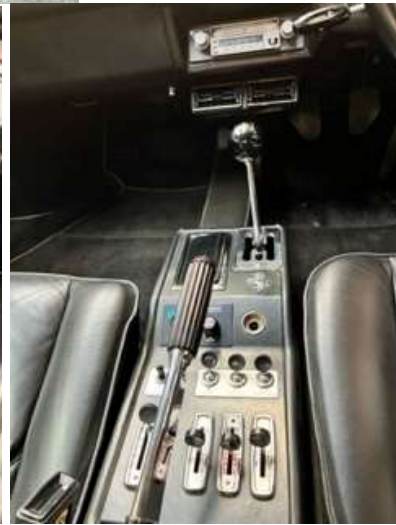
20-21

Area of Inspection	Comments
Cosmetic/Trim	All OK, Good but disting of paint on front of door card (Image 20-21)
Area of Inspection	Comments
Function	All works OK

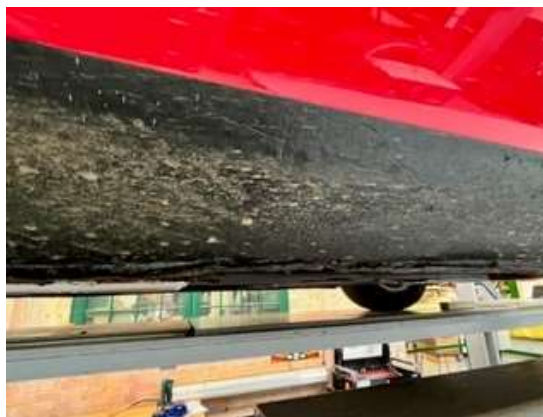
22

Area of Inspection	Comments
Chassis	All Good, No signs of heavy corrosion, Sills have slight corrosion coming through (Image 22)
Front/Rear Suspension	All Good, Bushes in good condition, No washers present on lower front suspension arms and bolt not fully through nylock Steering – Steering wheel loose, tightened on inspection, please observe this when driven. (Image 23-24)
Drivetrain	Drives nicely, goes through gears well
Exhaust System	All Good
Brake System	Disks and pads look close to new (Image 25-26)

Sill and arch arse small crack

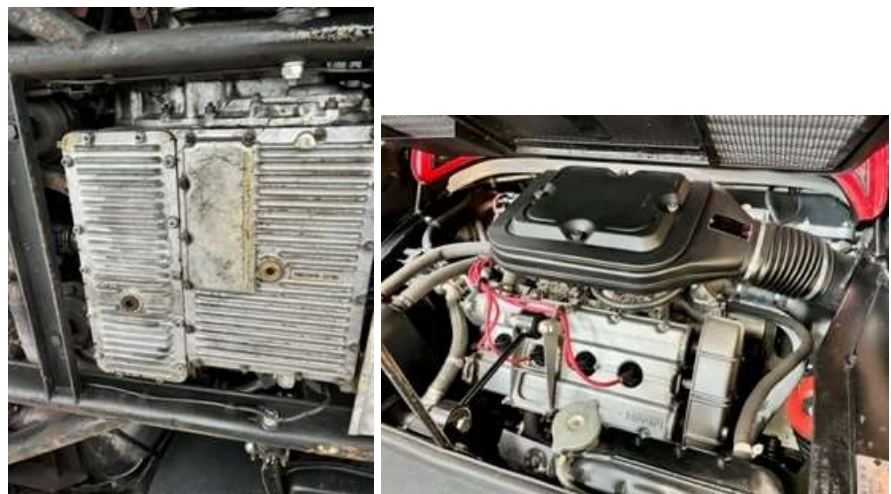
27-28

Area of Inspection	Comments
General View	Engine oil good Engine visual inspection (Image 27-28) Topped up header tank Two speak plug leads loose on inspection, clipped in properly on inspection
