Vehicle Inspection Report

Conducted by Classic Project Shop, Bicester

Date Completed 20th January 2022

Make	Ferrari	Engine no.	TBC
Model	456M GTA	Registration	NA
Chassis no.	ZFFWP50B000121329	Recorded Mileage	36,000KM

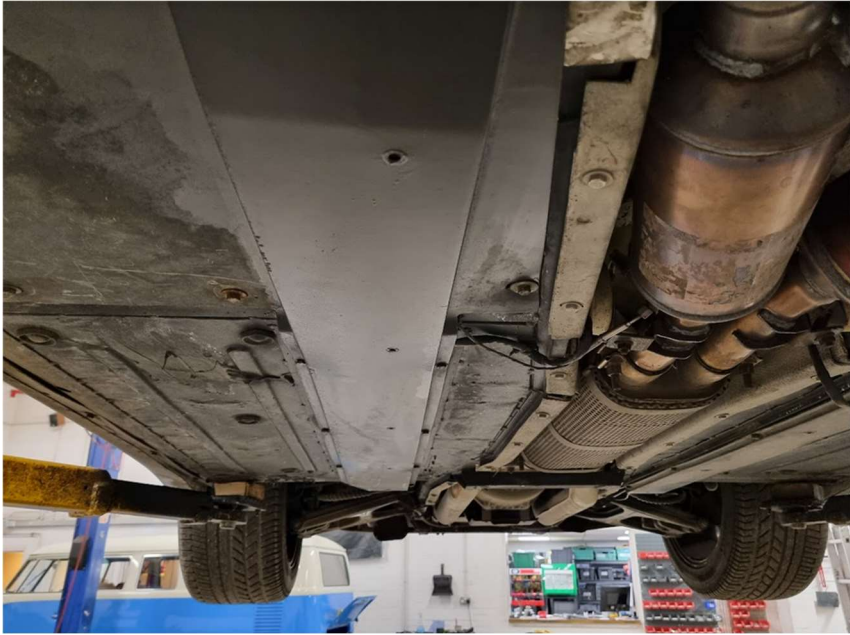
Underside	
Area of Inspection Chassis	Comments <ul style="list-style-type: none">• General condition is all good, clean and straight. Ref Pic 01 and 02
Area of Inspection Front/Rear Suspension	Comments <ul style="list-style-type: none">• Light surface corrosion on suspension arms and aluminium cross bars- Ref pic 03• Rear OS damper shows light oil misting Ref pic 04• Rear OS suspension reservoir shows slight oil mist Ref pic 05• Rear coil overs require the spring seats to be wound quite high to maintain ride height. Ride height is correct, but springs may be updated for stiffness with less travel than standard. Ref pic 04
Area of Inspection Drivetrain	Comments <ul style="list-style-type: none">• In good condition with no obvious play
Area of Inspection	Comments

Ref ID	Image
01	Underside general condition

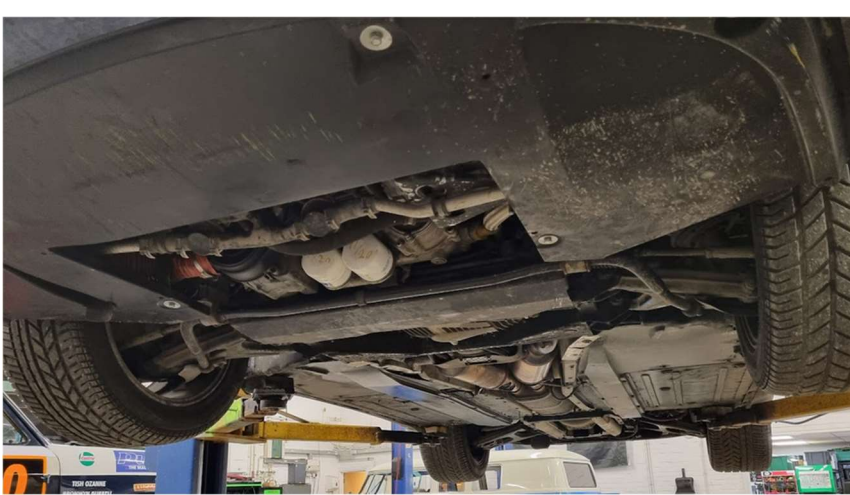
02	Underside general condition

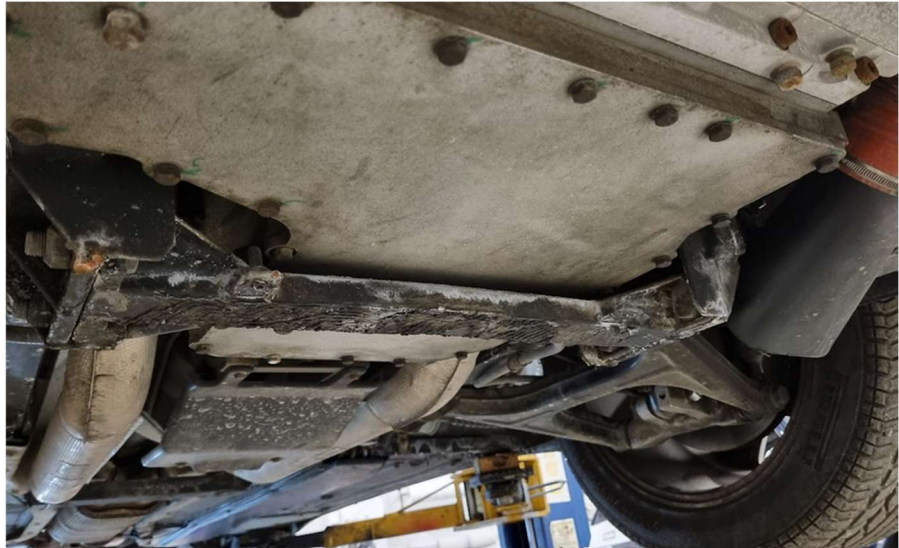
03

Suspension light corrosion

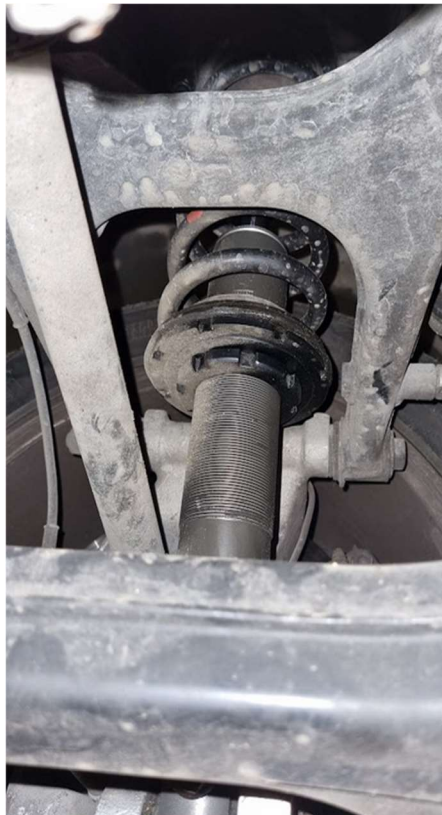
04

OS rear damper light oil misting and high spring seat

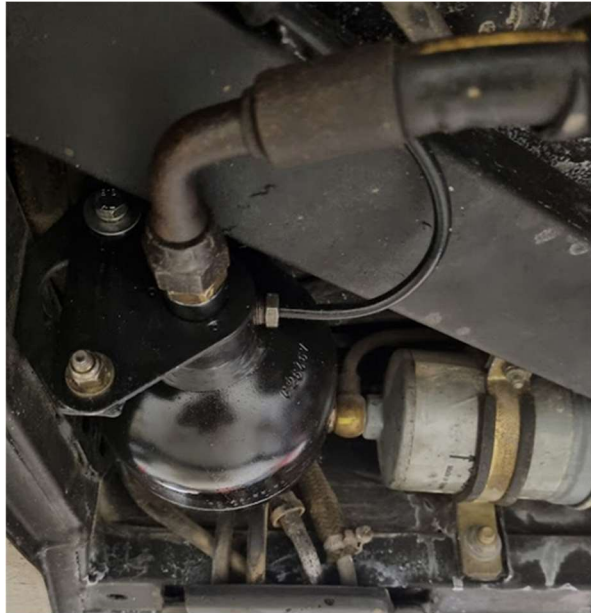
05

OS rear ride height revoir oil misting

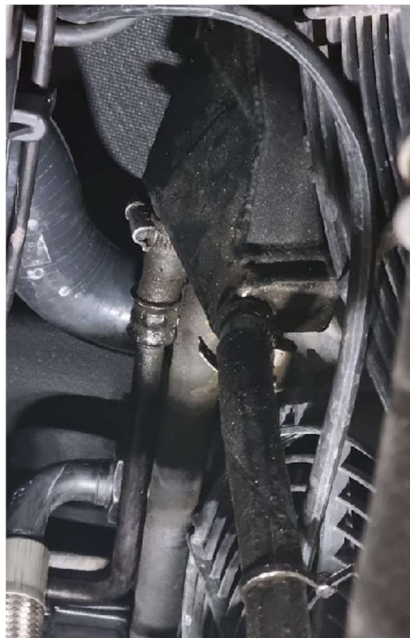
06

Area of Inspection	Comments
General View	<ul style="list-style-type: none">• Good general condition• Some oil misting around the breathers but not requiring immediate attention- ref pic 06• Oil levels correct and oil in good condition• Slight oil drop from filter canisters seals. Ref pic 07• Cambelt changed in 2021 as part of a comprehensive service.• Coolant levels good and fluid appears in good condition• Brake fluid appears to be dark in colour, would recommend a fluid change.

Breather reservoir oil misting
