Vehicle Inspection Report

Conducted by Classic Performance Engineering, Bicester

Date Completed 20/01/2022

Make **Sunbeam** Engine no.
Model **Rapier** Registration **LEB 478**
Chassis no. Recorded Mileage **97,259 miles**

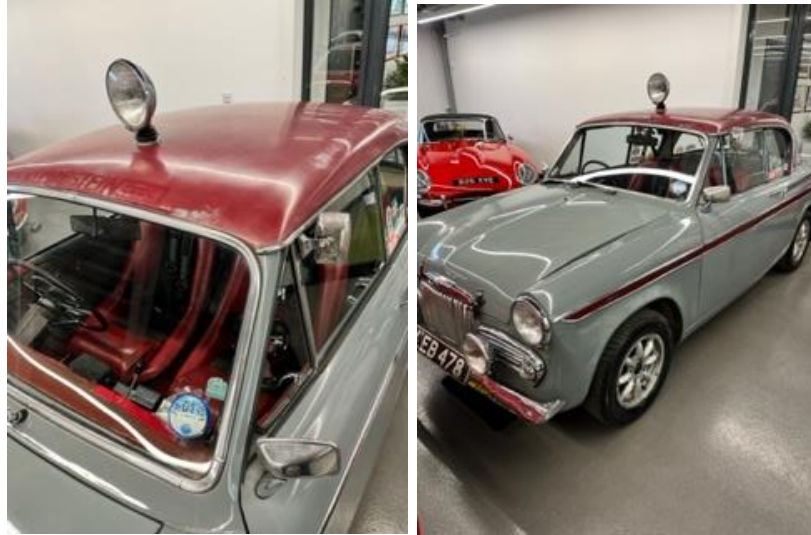
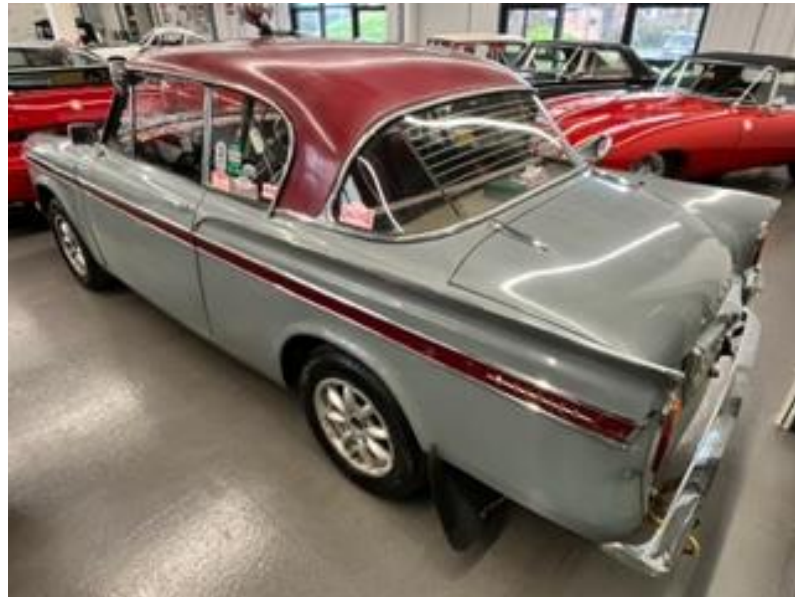
01-03

Area of Inspection	Comments																																				
Bodywork	As per images, working rally prepped car (Images 1-3)																																				
Brightwork	As per images, working rally prepped car (Images 1-3)																																				
Wheels & Tyres	See images (Images 4-7)

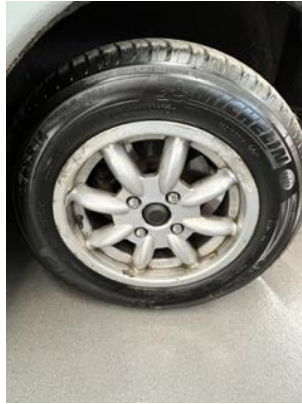
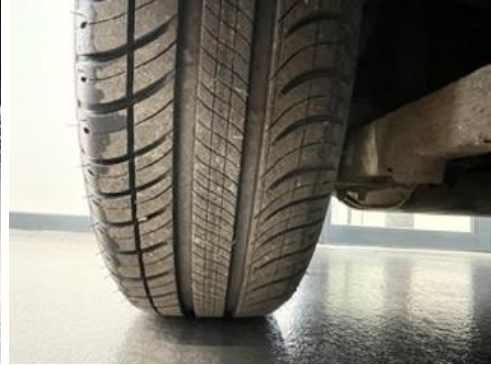
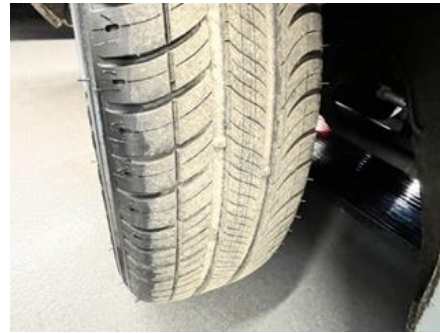
04-07

<table><tr><th>Position</th><th>Wheel Cond.</th><th>Original Spec.</th><th>Tyre Cond.</th><th>Size</th><th>Year</th></tr><tr><td>NSF</td><td>Surface wear</td><td></td><td>Good – Almost new</td><td>185 / 65 R14</td><td>2017/2018</td></tr><tr><td>OSF</td><td>Surface wear</td><td></td><td>“</td><td></td><td>“</td></tr><tr><td>NSR</td><td>Surface wear</td><td></td><td>“</td><td></td><td>“</td></tr><tr><td>OSR</td><td>Surface wear</td><td></td><td>“</td><td></td><td>“</td></tr></table>

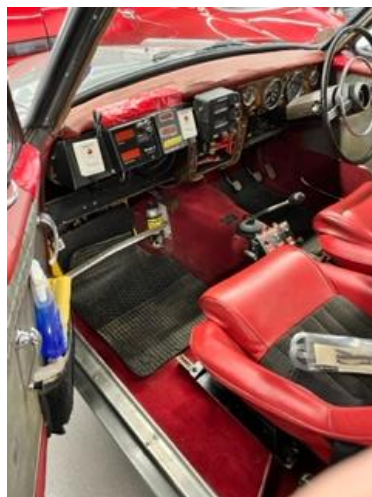
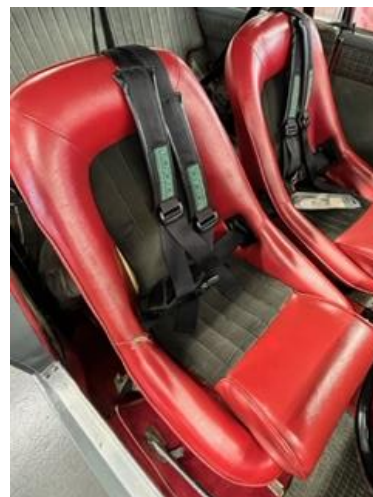
08-09

Area of Inspection	Comments
Cosmetic/Trim	Working rally prepped car, see images (Images 8-9)
Function	All switches work as they should (Images 10)

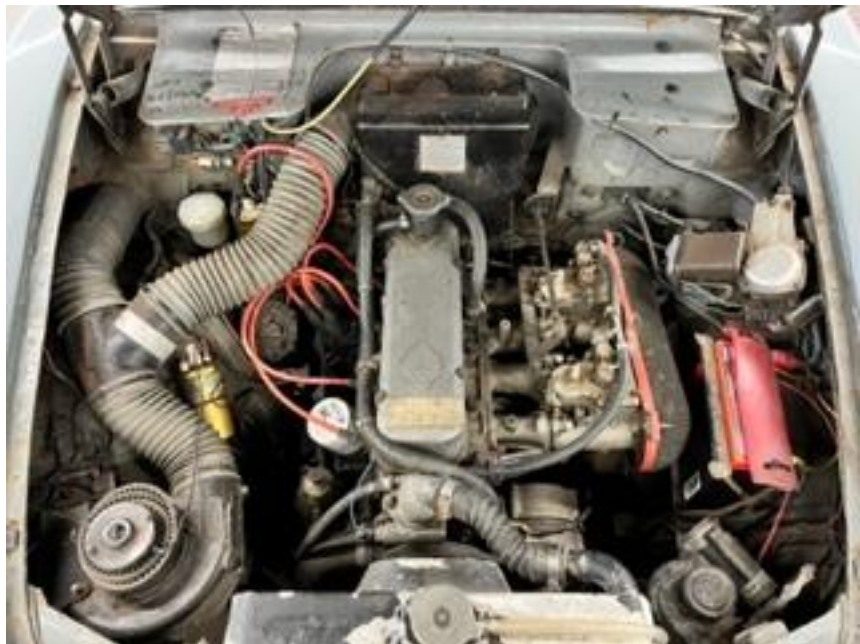
11

Area of Inspection	Comments
	Engine condition as per images, (Images 11)

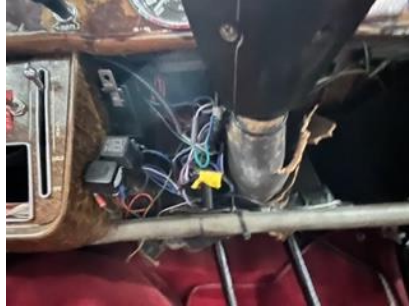
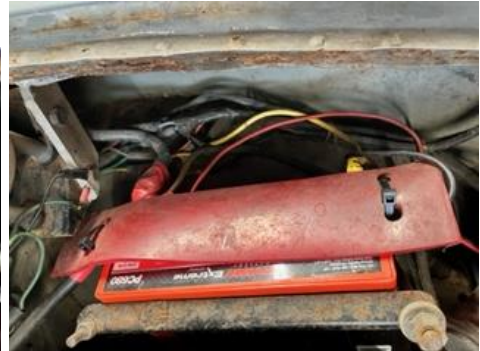
12-14

General View	Slight oil leaks in keeping with age and vehicle use, Have cleaned underside of gearbox to observe oil leak Wiring as per images attached (Images 12-14) Radiator has signs of leaks (Images 15)
---------------------	---

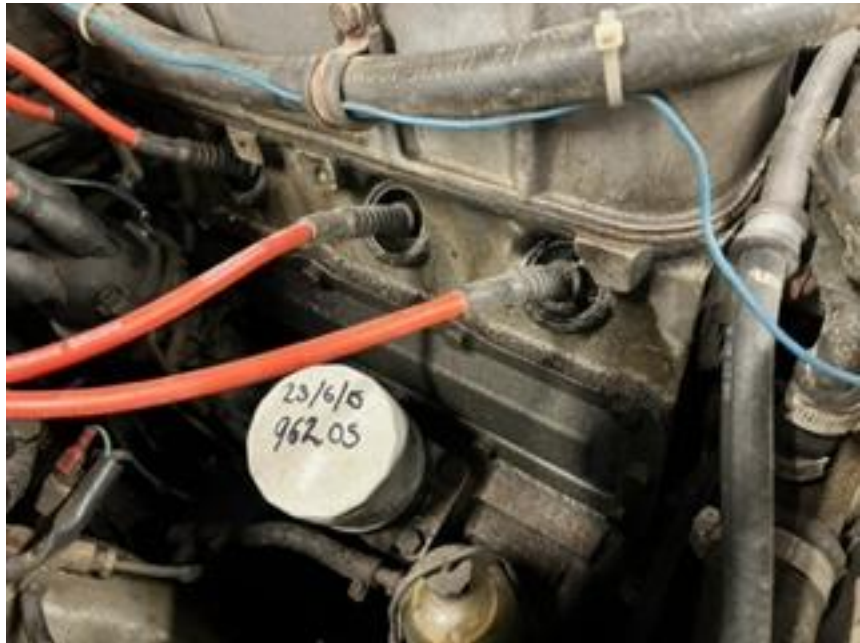
16

Area of Inspection	Comments
General Notes	Drives well for rally prepped car, Advise oil change, date on filter 23/06/15, oil very dark on inspection (Images 16)
