Vehicle Inspection Report

Conducted by Classic Performance Engineering, Bicester

Make	Triumph	Engine no.	
Model	TR3	Registration	UOC 784
Chassis no.	846606	Recorded Mileage	57074
Comm no.	TS13498

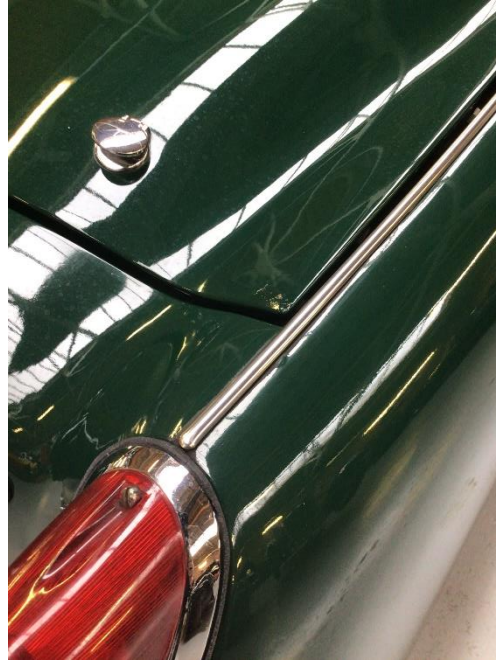
01

Area of Inspection	Comments																																				
Bodywork	Good condition, reasonable paint Hard top good Very slight corrosion on edge of boot lid (Photo ID 01)																																				
Brightwork	Only brightwork is rear ¼ bumpers – in good condition																																				
Wheels & Tyres	Wheels are in good condition There is good tread except left rear getting low Spare tyre good condition

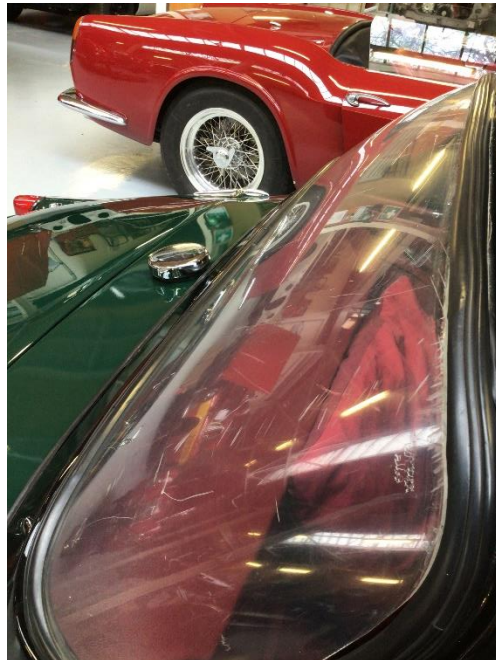
02

Area of Inspection Glass	Comments Good Perspex side windows, good (a little scratched) Rear screen scratched but serviceable (Photo ID 02)
Area of Inspection Lights	Comments All working Rear rain light not operational/switched
