Vehicle Inspection Report

Conducted by Classic Performance Engineering, Bicester

Date Completed 08/02/2022

Make	Ferrari	Engine no.	
Model	308GTB	Registration	308 AFK
Chassis no.		Recorded Mileage	88,665

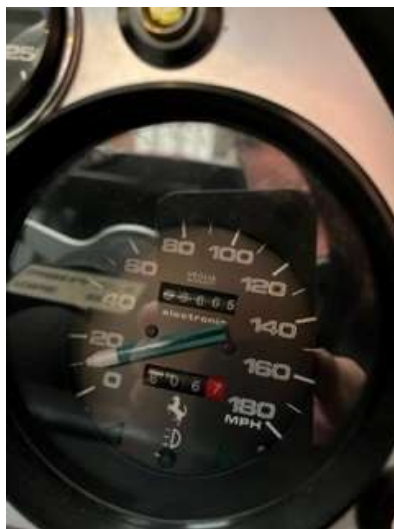
31

Area of Inspection	Comments
General Notes	Tyres are all 22+years old, Recommend replacement Trims on engine cover peeling off (Image 29-30) Mileage confirmation (Image 31) Tools and Engine Bay Storage (Image 32-33)
